Archeological excavations were undertaken at the Chestnut Hill Meeting House (1769) in Millville, Massachusetts during September of 2002. These excavations were conducted pursuant to Section 106 of the National Historical Preservation Act (NHPA) and concentrated on the northwest corner of the building. Five square meters of area were exposed during the subsurface archeological testing (three 1 x 1 meter units and four 0.5 x 1 meter units). Archeological excavations uncovered parts of the building foundation, the stone fill for a retaining wall along the street, and a posthole and postmold possibly related to a hitching post. Other than nails and window glass fragments, few artifacts were recovered. No human remains were discovered. These excavations demonstrated that the installation of a concrete pier under the northwest corner of the building will not have an adverse impact on the archeological deposits.

**MANAGEMENT SUMMARY:  
INTENSIVE ARCHEOLOGICAL TESTING  
AT THE CHESTNUT HILL MEETING HOUSE,  
BLACKSTONE RIVER VALLEY NATIONAL HERITAGE CORRIDOR,  
MILLVILLE, MASSACHUSETTS**

William A. Griswold, Ph.D. and William A. Cooney  
Archeology Group, Philadelphia Support Office  
No

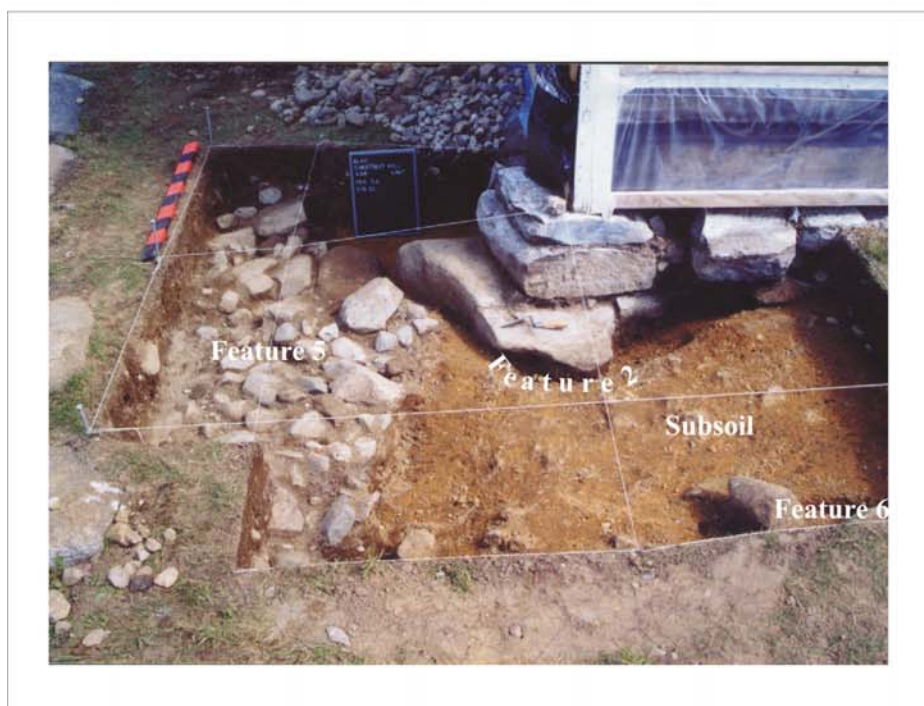
Figure 2.7 Photograph showing Feature 5 before its partial excavation in Test Unit 2.

Feature 5 was the stone fill behind the retaining wall running along the edge of the street. This retaining wall provided an elevated ground surface of approximately 50 cms above the level of the road and helped support the foundation of the building. The stone fill of Feature 5 extended up to the foundation stones for the northwest corner of the building. It is likely, then that the retaining wall and stone fill were deposited at or around the time of the construction of the building. A portion of Feature 5 was removed in Test Unit 2 to confirm that the stones were actually fill deposits and not any other type of feature (e.g. a wall, or stone path). The stone fill appeared to be deposited on top of the subsoil (Stratum 3). Only a small portion of the fill was removed (for verification) due to the fear of destabilizing the corner of the building.

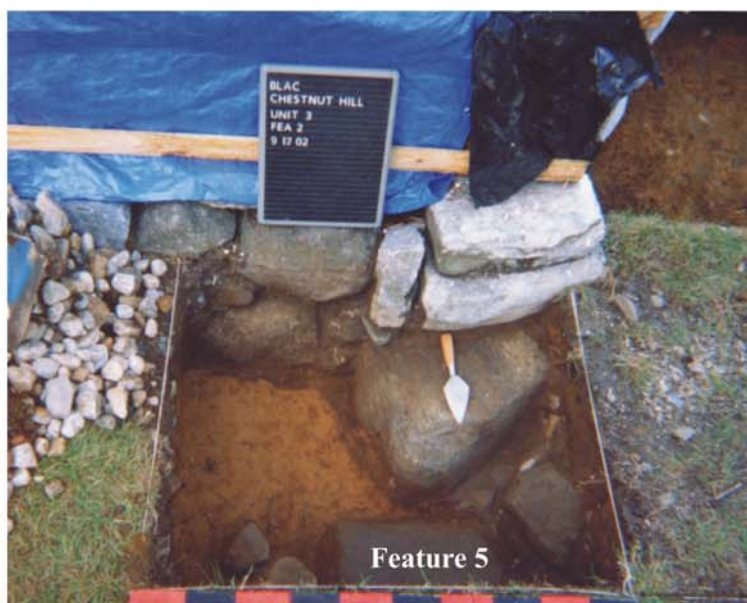
Figure 2.9 Photograph of Test Unit 3 during excavation.
